STRUCTURAL ASSESSMENT OF THE RUDDERBLADE OF A HIGH-PROFILE RACING YACHT

NON-DESTRUCTIVE EXAMINATIONS SPECIFIC FOR THE YACHTING INDUSTRY

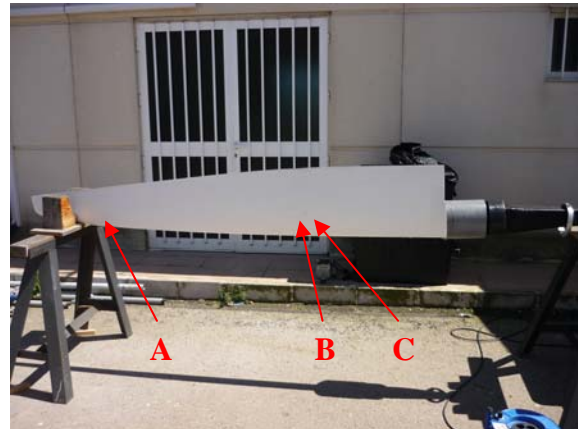
Shearography examination indicated three areas of discontinuity in the composite structure. These were believed to be partial disbonds of the secondary bondline between the carbon fibre rudderstock and the half-shells.

The three discontinuities detected on the rudder

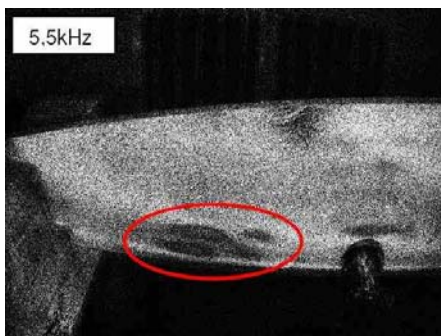
Discontinuity 'A' on the port side of the rudder

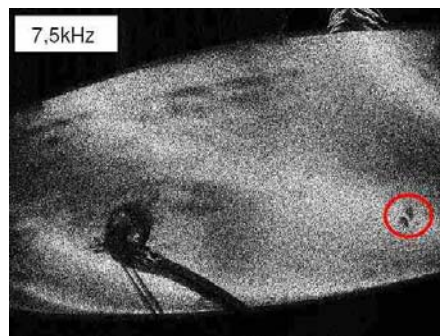
Discontinuity 'B' on the port side of the rudder

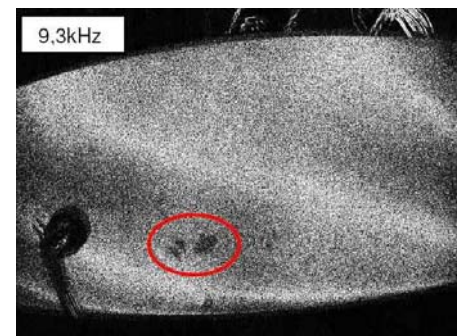
Discontinuity 'B' and adjacent discontinuity 'C'.
