DE-LAMINATIONS IN A MONOLITHIC CARBON MAST

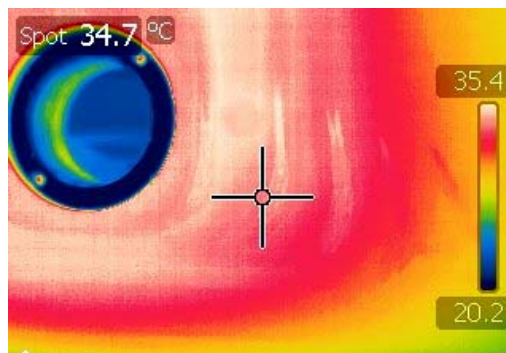
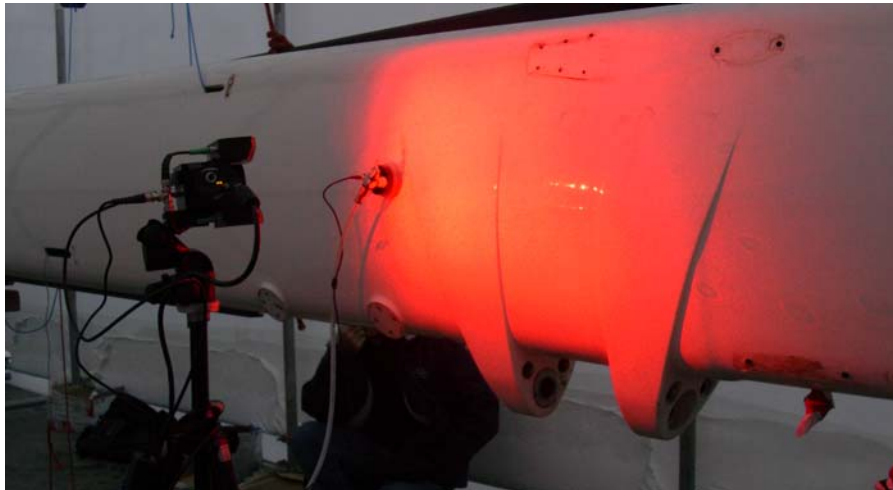
In a number of places hairline cracks were noted in a mast constructed of monolithic carbon fibre of approximately 110ft in length. Suspicious of de-laminations, the owner requested a full inspection of all the spars. All the hairline cracks were noted in reinforced areas around vang, gooseneck and spreader root fittings.

Infrared Thermography did not produce reliable results on the mast due to difficulties in achieving an even temperature through the reinforced areas.

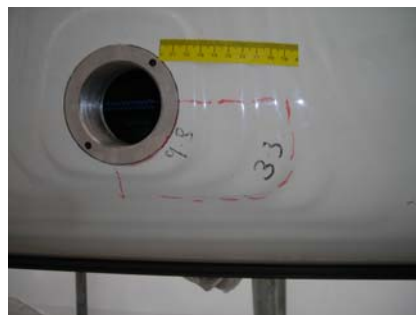
All areas of de-lamination were clearly indicated, size and depth of the flaws were marked for the repair. Shearography confirmed all delaminations found by Ultrasonic Flaw Detection.
