WATER INGRESS IN A PVC FOAM CORE

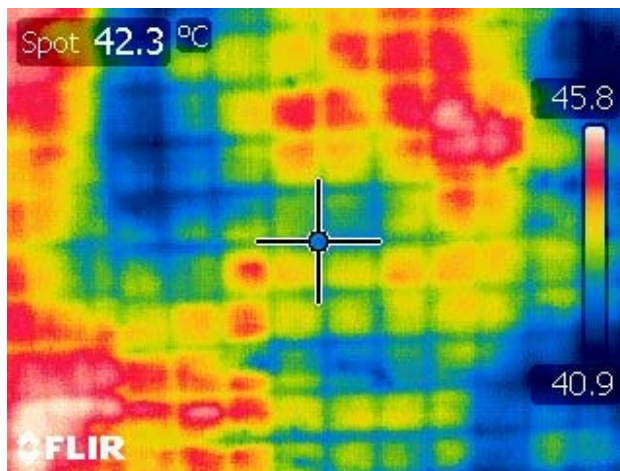
During the installation of a new through-hull fitting in the hull bottom of a large composite vessel of sandwich construction, it was noted that the foam core material was wet. In order to obtain quotes for a repair, the Captain requested a through quantitative assessment of the affected area. Construction drawings indicated that the outer FRP skin had an approx thickness of 8 mm, with a 25 mm high-density (100 kg/m³) foam core.

It was further possible to determine that water ingressed the sandwich structure at a faulty through-hull fitting and migrated to other areas via partly unfilled kerfs.

Blue areas (colder) in the Thermograph here above indicate areas saturated with water. Note channelling of water into kerfs of PVC core.

Knowing the precise amount of area affected, as well as its cause, allowed owners / managers to make informed decision regarding the repair.
