ASSESSMENT OF DAMAGE TO INTEGRAL FRP WATERTANK

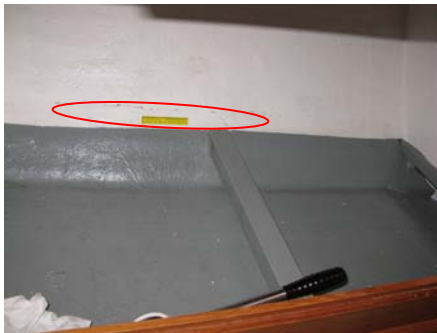
The visual inspection revealed an approx 670mm long hairline crack along the top edge of the tabbing. Hammer sounding revealed that the area (tabbing) directly (approx.10mm) below the above mentioned crack was delaminated / debonded. All other areas appeared to be free of anomalies.

Visual hairline crack at the upper end of the tank-tabbing.

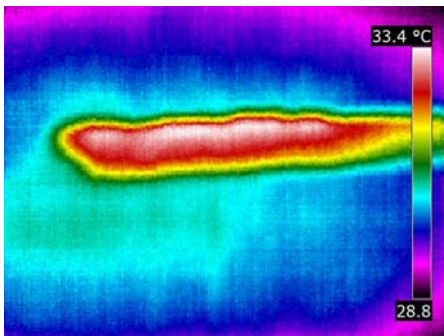
Infrared Thermography revealed a large disbond between the pre-moulded hull shell and the tabbing for the tank (secondary bonding).

The Infrared picture shows the area affected to be considerably larger than visual inspection and hammer tapping indicated.

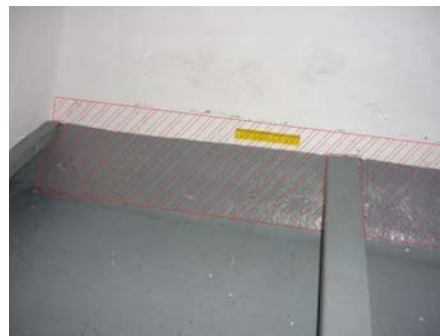
Ultrasonic Flaw Detection not only confirmed the disbond but revealed that the area affected was extending largely beyond both the visible anomaly and the area detected by Infrared Thermography.

Actual area affected by debonding as indicated by Ultrasonic Flaw Detection

Due to the position of the tank in the forward part of the vessel, and its purpose as replacement for a longitudinal reinforcement, the extent of the damage was deemed to be structurally critical.
