**NON-DESTRUCTIVE EXAMINATIONS
SPECIFIC FOR THE YACHTING INDUSTRY**

DAMAGE TO A GRP HULL

CASE STUDY 5

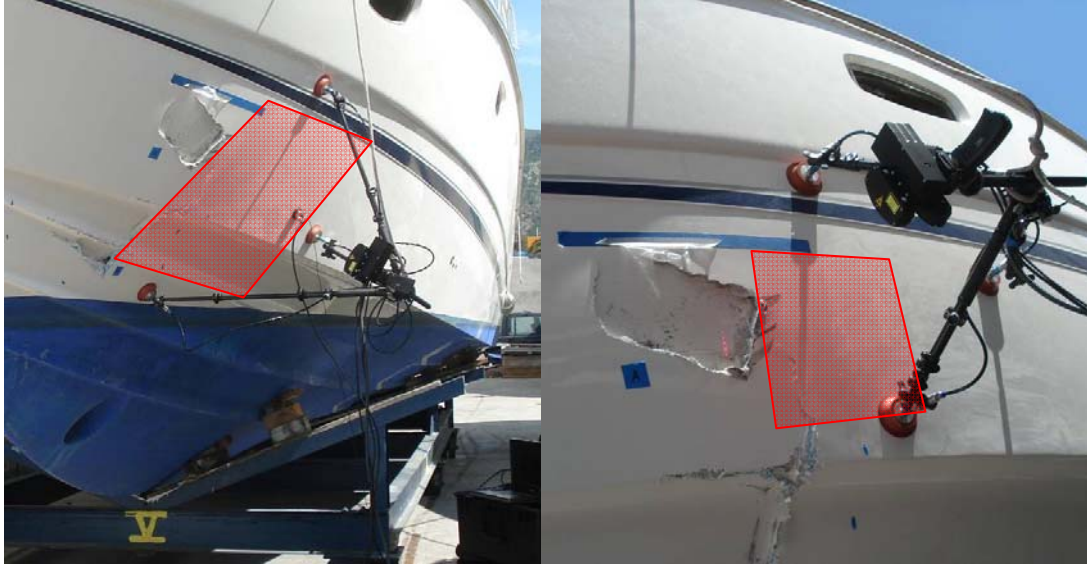
A large hole in the forward part of the hull and a number of connected cracks, did not allow the inspection of the area with a vacuum hood system.

The inspection rig placed in way of severe damage to the hull.
