**NON-DESTRUCTIVE EXAMINATIONS  
SPECIFIC FOR THE YACHTING INDUSTRY**

**DAMAGE TO A GRP HULL**

CASE STUDY 5

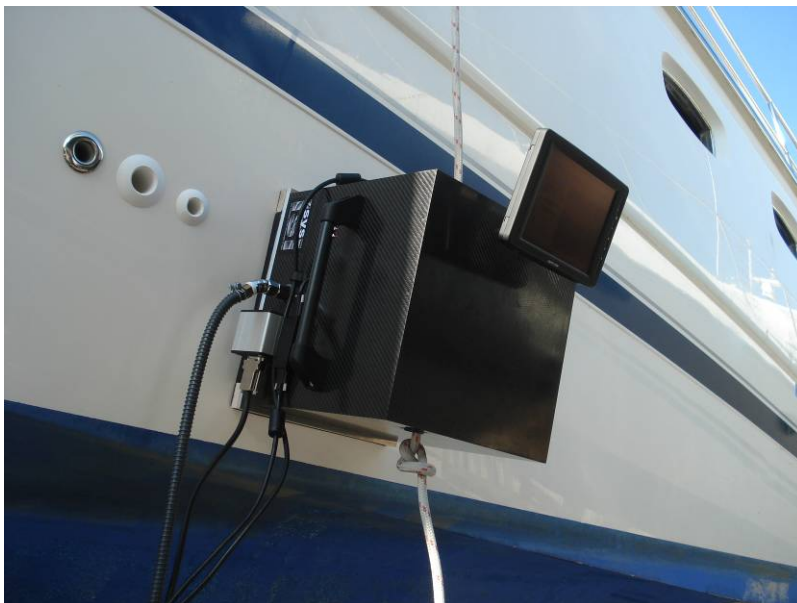
The vacuum hood attached to the side of the GRP production motor yacht

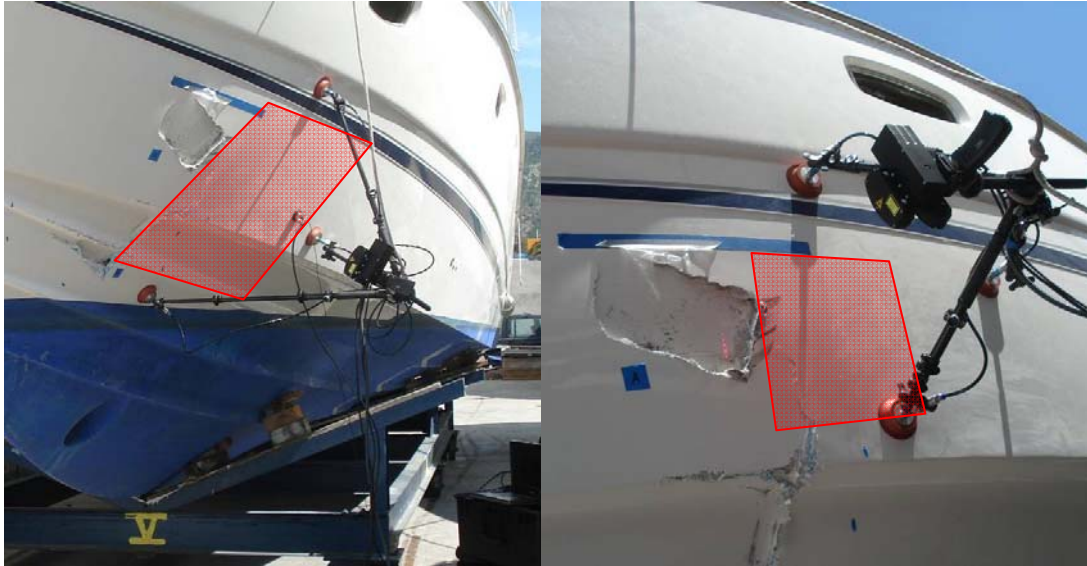
A large hole in the forward part of the hull and a number of connected cracks, did not allow the inspection of the area with a vacuum hood system.

The inspection rig placed in way of severe damage to the hull.
