DAMAGE TO A GRP HULL

CASE STUDY

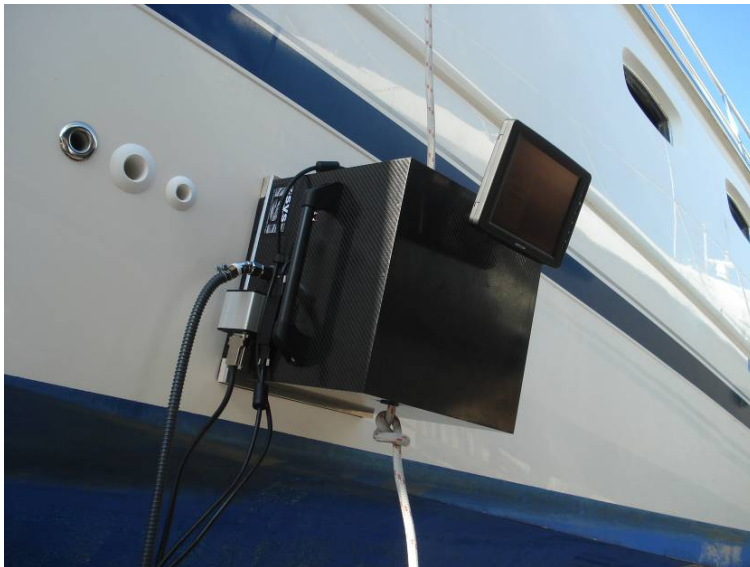
The vacuum hood attached to the side of the GRP production motor yacht

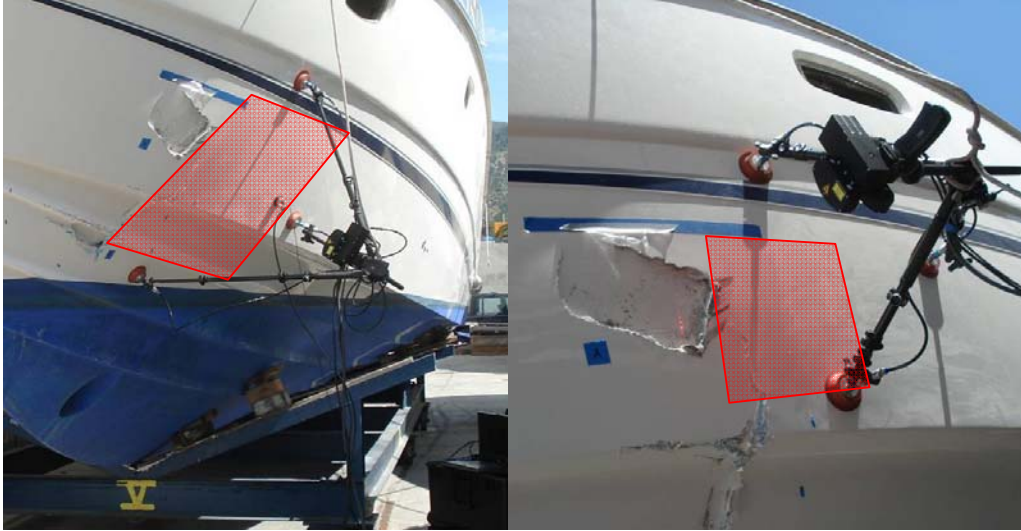
The inspection rig placed in way of severe damage to the hull.
