STRUCTURAL ASSESSMENT OF THE RUDDERBLADE OF A HIGH-PROFILE RACING YACHT

CASE STUDY

**NON-DESTRUCTIVE EXAMINATIONS
SPECIFIC FOR THE YACHTING INDUSTRY**

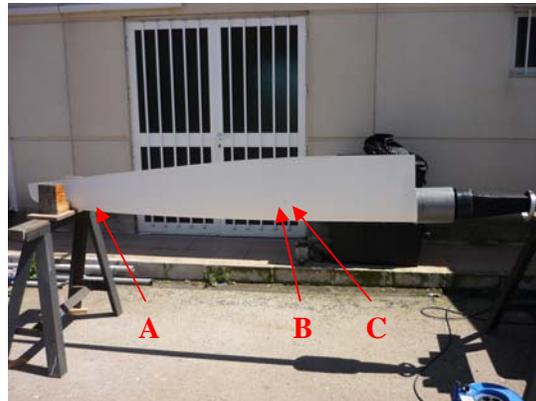
Shearography examination indicated three areas of discontinuity in the composite structure. These were believed to be partial disbonds of the secondary bondline between the carbon fibre rudderstock and the half-shells.

The three discontinuities detected on the rudder

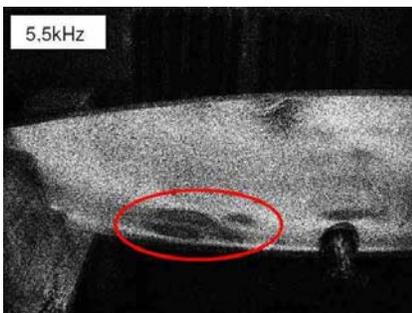
Discontinuity 'A' on the port side of the rudder

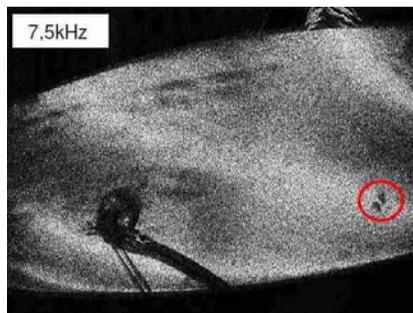
Discontinuity 'B' on the port side of the rudder

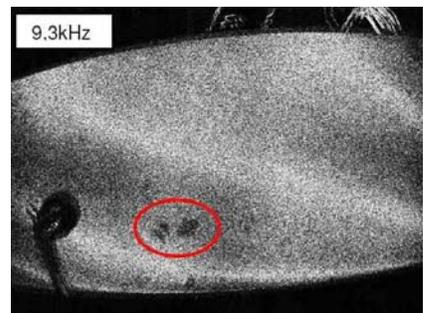
Discontinuity 'B' and adjacent discontinuity 'C'.
