WATER INGRESS IN A HONEYCOMB CORE

CASE STUDY

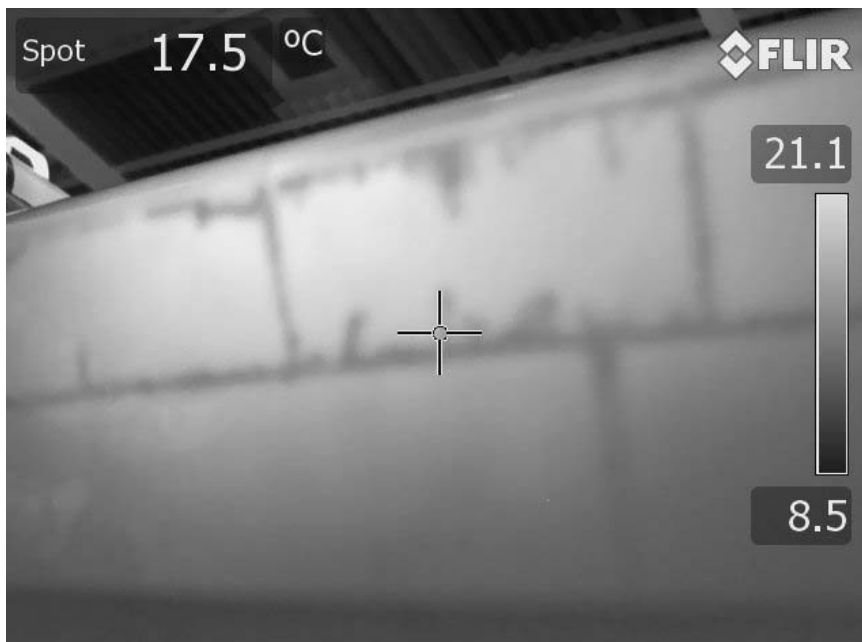
During a winter refit period of a sailing yacht, which included some modifications to the hull, water was noted exiting out of the primary hull. The hull was reportedly build in pre-preg carbon epoxy composite (CFRP) over Kevlar honeycomb core in most areas. Only the hull bottom in the slamming area forward of the keel was cored with Divinycell foam core.

A quantitative assessment was made and all area affected by water ingress were mapped using active Infrared Thermography. All affected areas were further inspected using Laser Shearography to identify possible planar discontinuities. Additional pull-off test were carried out to provide a vast array of information to the owners / structural engineers to make informed decision regarding the repair.
